ASC-TR-2010-5002

THREATS TO AIRCRAFT STRUCTURAL SAFETY, INCLUDING A COMPENDIUM OF SELECTED STRUCTURAL ACCIDENTS / INCIDENTS

**Engineering Directorate (ASC/EN)
Aeronautical Systems Center**

**MARCH 2010
Final Report**

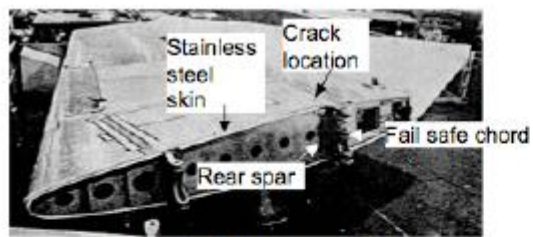
Figure A18: Photo of Right Horizontal Stabilizer that Separated from B-707-321C Aircraft and Details of “Fail-Safe” Structure Associated with the Accident

On May 14, 1977, a Boeing 707-300 operated by Dan-Air Services crashed on approach to Lusaka International Airport, located in Lusaka, Zambia. The accident was caused by the fatigue failure of the right horizontal stabilizer or tail-plane. This was followed by a loss of control and the crash killing all 6 occupants. While the aircraft had been certified as fail-safe per the 1956 CAR 4b.270 requirements, the upper rear spar chord failure (which occurred about 100 flights earlier) was not discovered prior to the failure of the fail-safe chord during this final landing approach. See a photograph and a sketch of the design in Figure A18 [A19].

Post accident flight tests revealed that deployment of the speed brakes during landing role produced a horizontal load spectrum, which was significantly more severe than assumed during the original design. Obviously, a good knowledge of both the external loads (and load spectrum) and the local internal loads are essential in predicting crack initiation, crack growth and fail-safe residual strength, which leads to this second lesson-learned:

It is essential that load surveys be performed to develop accurate loads and load spectra (including both ground and flight loads) for use in damage tolerance (i.e., crack growth) analyses, fatigue analyses and fail-safe residual strength and life analyses. These load spectra are also very important for the full-scale fatigue test.

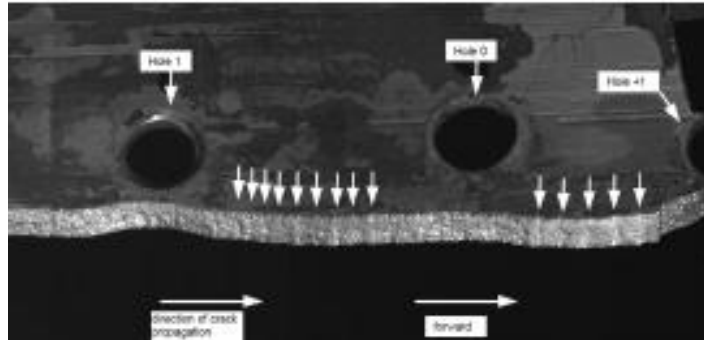
Figure C15 is a photograph of a portion of the fracture face showing bands of fatigue growth following increments of unstable crack growth and arrest (i.e., termed quasi stable growth by BMT). Each of the bands of fatigue growth represents a number pressurization cycles. Note that the crack location is outside the outer row of fastener holes, but still covered by the doubler.

Figure C15: Quasi-stable Crack Growth Identifying Numerous Starter Cracks (Prior to Final Fracture) [C9].

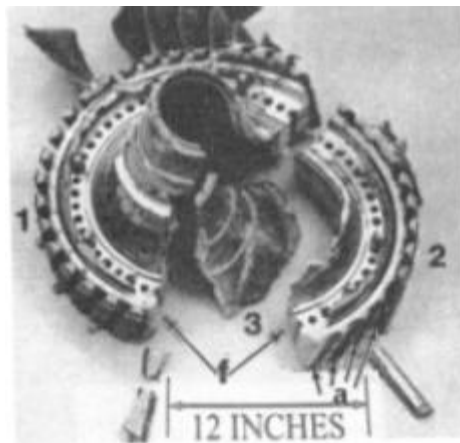
Figure F12. Photo of Fractured Pratt & Whitney Compressor Fan Disk

The National Transportation Safety Board determined that the probable cause of this accident was the fracture of the left engine's front compressor fan hub (i.e., disk) as shown in Figure F12, which resulted from the failure of Delta Air Lines' fluorescent penetrant inspection process to detect a detectable fatigue crack initiating from an area of altered microstructure (i.e., a manufacturing defect) that was created during the drilling process by Volvo for Pratt & Whitney and that the defect went undetected at the time of manufacture.

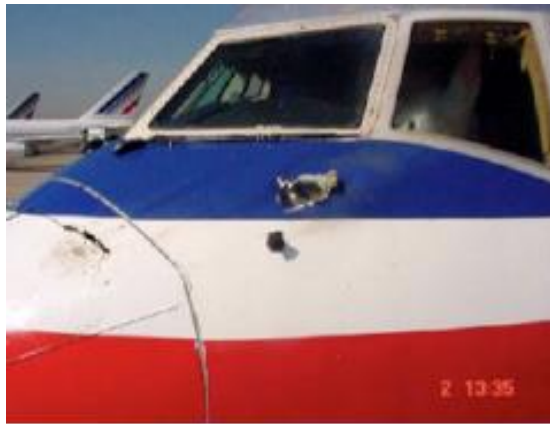
Figure G3: Photo of Bird Strike Damage to B767 Aircraft Just Below the Cockpit Windows

On April 2, 2001 an American Airline's 767-300 enroute from Paris to Miami encountered a flock of large birds while climbing through 12,000 feet. The radome, fuselage and wing leading edge all received extensive damage as shown in the photographs below. One of the large birds, believed to be cormorants, penetrated the cockpit area through the radome and forward pressure bulkhead. The aircraft depressurized and the crew landed the plane in Paris with no injuries [G2].

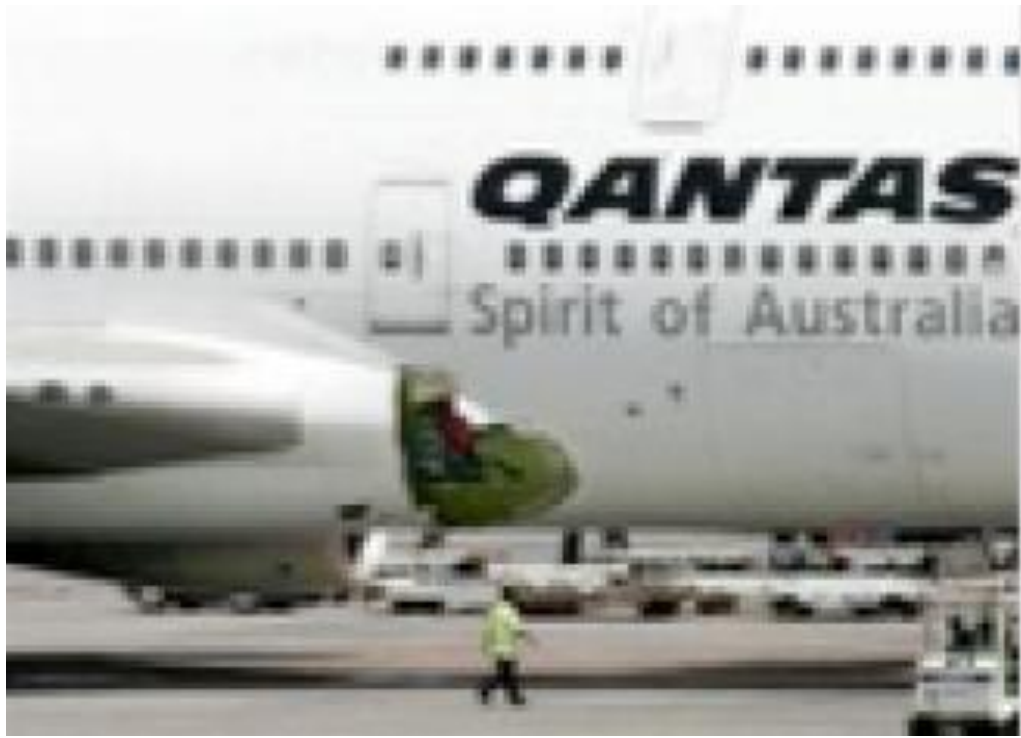
Figure I2: Photo of Boeing 747 Fuselage after On-Board Explosion

On July 25, 2008 a Qantas Airline Boeing 747 enroute to Melbourne, Australia from London was cruising at 29,000 feet when it experienced an explosive decompression of the fuselage. Per standard procedure the plane immediately descended to 10,000 feet and minutes later made an emergency landing at the Manila airport in the Philippines. There were 346 passengers onboard and there were no fatalities or injuries to any of the passengers or crew. Upon post flight examination a large hole was seen in the lower right side of the fuselage just forward of the wing. This is shown in the photographs in Figures I2 through I4 [I1].

On August 29, 2008, the Australian Transportation Safety Bureau (ASTB) confirmed that the incident was caused by the bursting of one of two oxygen bottles that were located in this area of the cargo compartment and has been found to be missing. Also, shards from the missing oxygen bottle and the oxygen regulator valve were found in the fuselage. This investigation the failure provides another strong testament to the importance of having fail-safe structures with large design damage sizes.

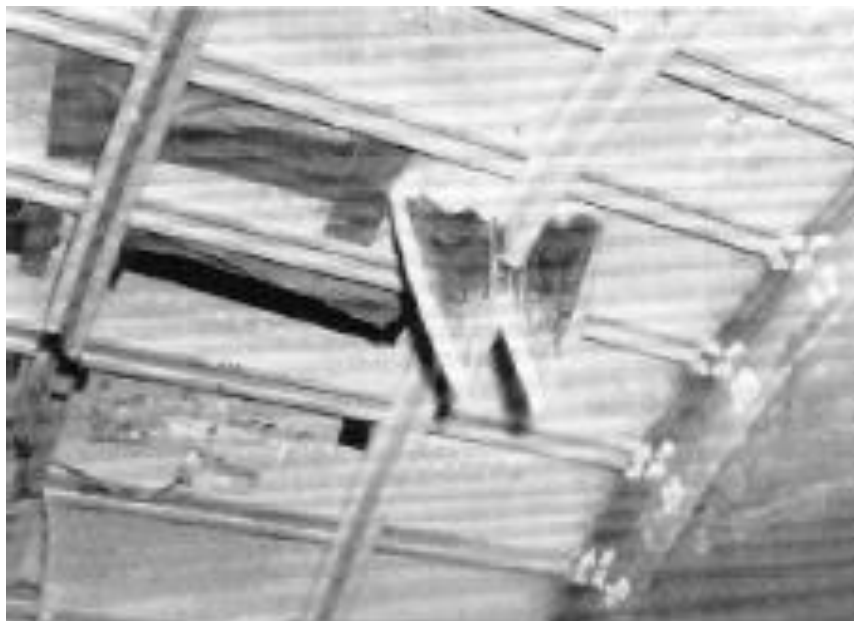
Figure K3: Boeing 737 Blade Penetration

Fuselage fail-safe tests were continued with the development of the 737, but with a double bladed guillotine so as to sever the central frame as well as the skin. The test fixture is shown in Figure K2; the double bladed penetration is shown in Figure K3; and, the final two bay arrested crack with broken frame is shown in Figure K4.
